# Nordic Upstream for LSJH

PROJECT CODE: “6Aika: ILPO – A75909”

DATE OF REPORT: 26.11.2021

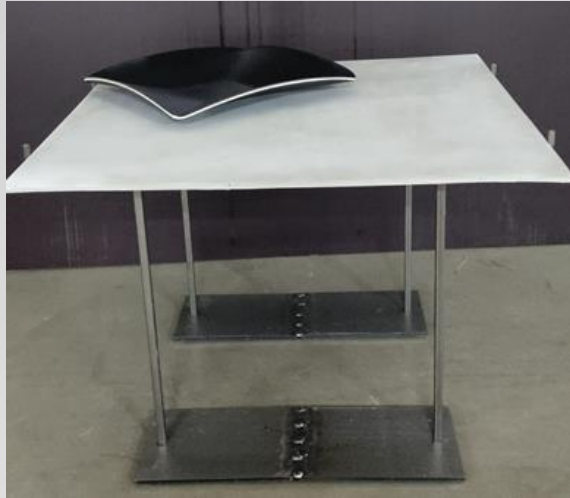
- **Table**

- Products include 2 chairs, a table and a artwork - all made from old materials/left-overs/recycled materials
- **2 chairs**, from local recycling centre Ekotori, Turku
  - With textile matt (airflow, needle punched)
- **Table**, concrete top from LSJH materials, metal frames from upcycled material display units
  - Crushing of the materials down to 0-8 mm grain size
  - Welding existing displays into one single framework
- **Artwork**, textile-wood-recycled LSJH materials upcycled into artwork
